TEST REPORT

No.: SZV1609056

Sample Name: Downlight

Model: DL-1、DL-2、DL-3、DL-4

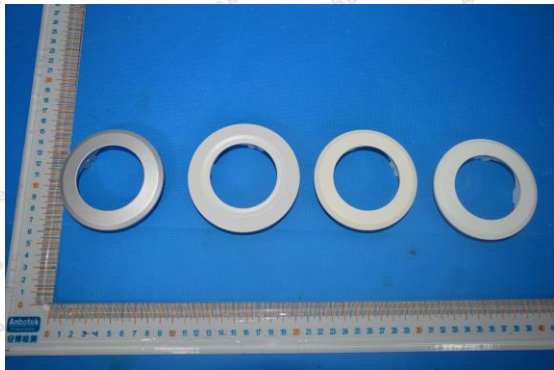
Sample as received		Test up

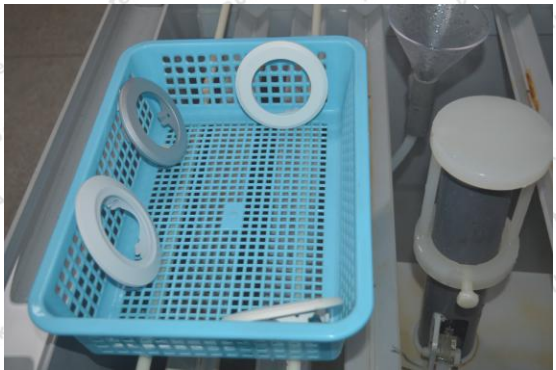
1. Nature Salt Spray test				
Test Method	GB/T 10125-2012			
test Condition	Nature Salt Spray test Solution concentration: 50 g±5 g/L Chamber temperature: 35 °C Pressure barrel temperature: 47 °C PH value of solution: 6.5~7.2 Salt spray settlement(ml/ 80cm ² /h): 1.0~2.0 mL/h Spray model: Continued Test Time: 12hrs			
Test Equipment	Equipment Name	Equipment No.	Model	Validity Period
	Salt spray chamber	SE-1096	SN-120	8.23,2017
Test Result	Sample No.	Test Result	Defect Area A(%)	Protection Rating
	1	After test, the sample surface had no obvious rust and corrosion by visual inspection.	0<A≤0.1	9
	2	After test, the sample surface had no obvious rust and corrosion by visual inspection.	0<A≤0.1	9
	3	After test, the sample surface had no obvious rust and corrosion by visual inspection.	0<A≤0.1	9
	4	After test, the sample surface had no obvious rust and corrosion by visual inspection.	0<A≤0.1	9
Photos
