TEST REPORT

No.: SZV1609056

Sample Name: Downlight

Model: DL-1、DL-2、DL-3、DL-4

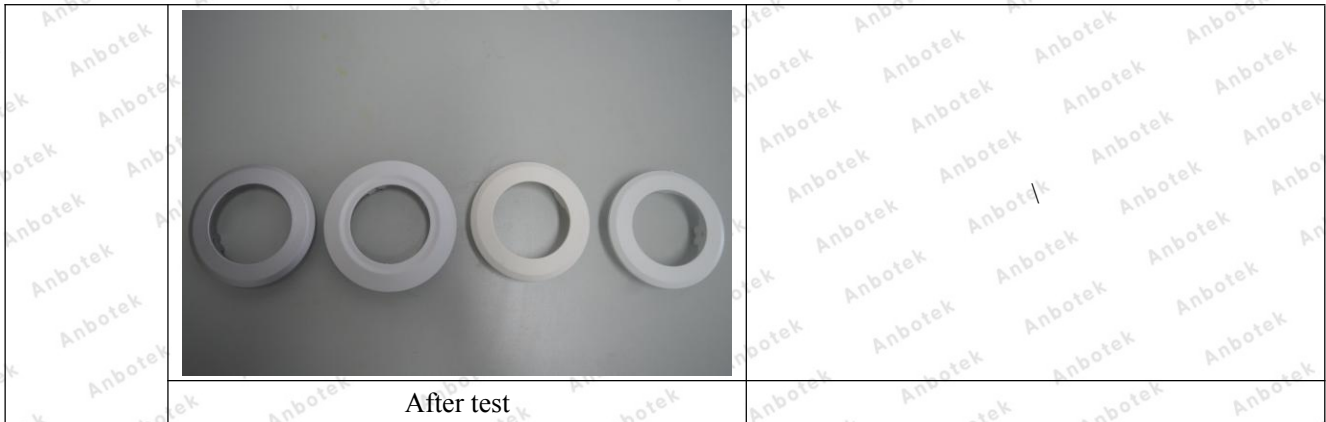
1. Nature Salt Spray test				
Test Method	GB/T 10125-2012			
test Condition	Nature Salt Spray test Solution concentration: 50 g±5 g/L Chamber temperature: 35 °C Pressure barrel temperature: 47 °C PH value of solution: 6.5~7.2 Salt spray settlement(ml/ 80cm ² /h): 1.0~2.0 mL/h Spray model: Continued Test Time: 12hrs			
Test Equipment	Equipment Name	Equipment No.	Model	Validity Period
	Salt spray chamber	SE-1096	SN-120	8.23,2017
Test Result	Sample No.	Test Result	Defect Area A(%)	Protection Rating
	1	After test, the sample surface had no obvious rust and corrosion by visual inspection.	0<A≤0.1	9
	2	After test, the sample surface had no obvious rust and corrosion by visual inspection.	0<A≤0.1	9
	3	After test, the sample surface had no obvious rust and corrosion by visual inspection.	0<A≤0.1	9
	4	After test, the sample surface had no obvious rust and corrosion by visual inspection.	0<A≤0.1	9
Photos
